**Report for
Specific Scope Renovation, Repair and Paint
Lead-Based Paint Survey
(RRP Survey)**

**Job # 2013-6-3 1971 River Road
Survey Date: June 3, 2013
Property Address: 1971 River Road
Jacksonville, Florida 32207
Home Built 1930**

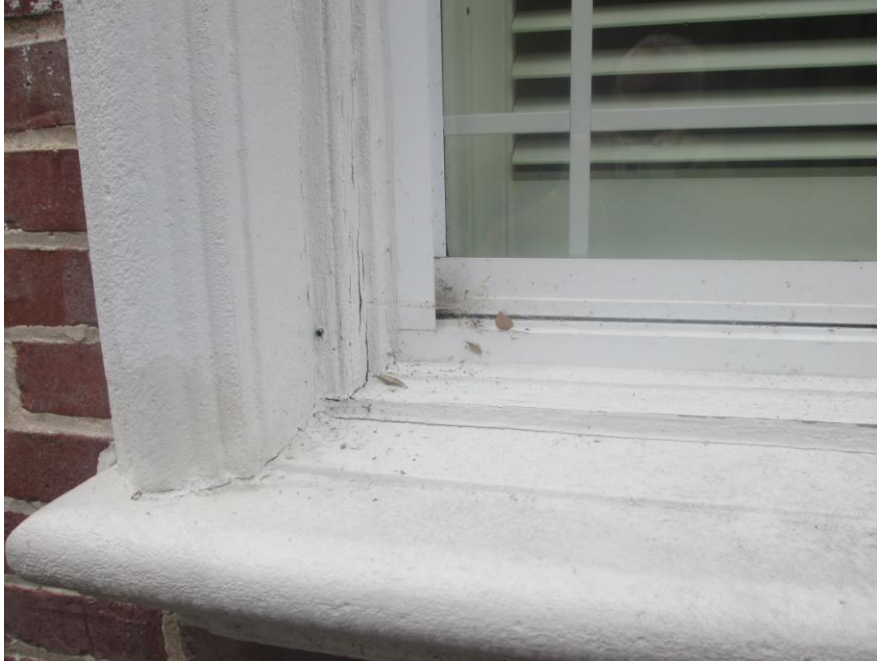
Lead based paint was located on the original fascia and window framing. See the attached XRF readings and photographs for specific details and locations of lead based paint.

Original wood contains lead based paint

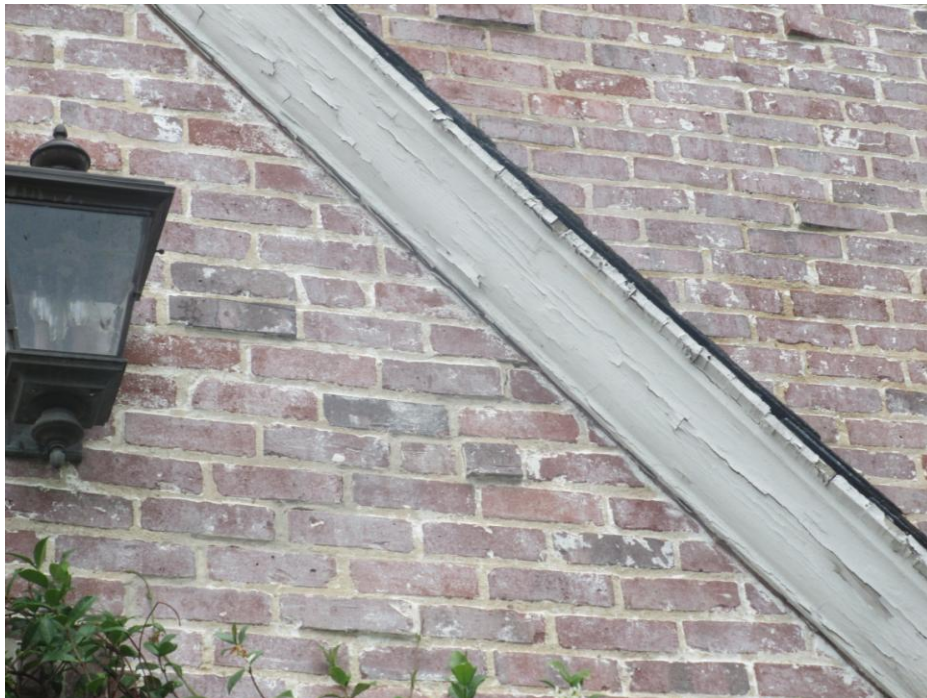
Read No.	Wall	Structure	Location	Member	Paint Cond	Substrate	Paint Color	Lead (mg/cm ²)	Mode
Exterior Room 001									
105	A	Fascia	Ctr		P	wood	white	8.1	QM
107	A	Window	Ctr	Rgt casing	P	wood	white	1.0	QM
104	B	Fascia	Ctr		P	wood	white	8.7	QM

Fascia contains deteriorated lead based paint and is a hazard.
